DCIEM (REPORT NO. 850)

04a HUMAN FACTORS EVALUATION OF  
- THE ARGUS (CP-107) AIRCRAFT (U)

DEFENCE AND CIVIL INSTITUTE OF ENVIRONMENTAL MEDICINE

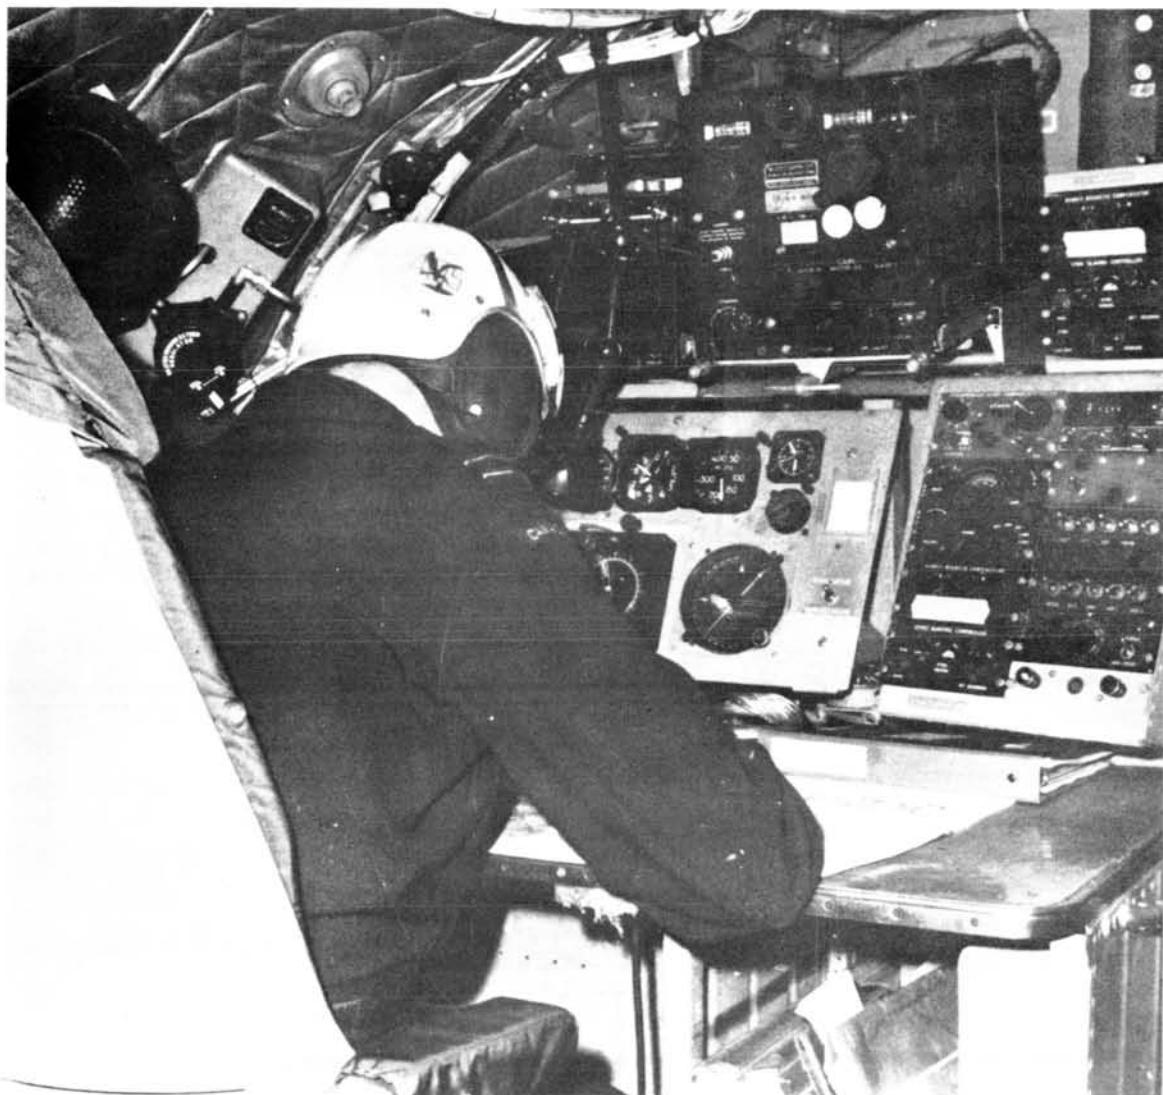
obscures a number of displays (see Figure 3). Legibility of some dials is extremely poor and additional information is required to eliminate dependence on the Pilot or Tactical Navigator. Grouping of equipment by function is substandard, there are far too many manual controls, and some controls are susceptible to accidental switching. The capabilities of the instrumentation do not appear adequately matched to the aircraft's present role. Some personal equipment, particularly the helmet, are sources of discomfort in the Navigator's working posture.

*Figure 3. The lamp obscures displays and controls at the tourine navigator's station.*

Short-term improvements are not really the answer to the inadequacies of this station. It would be possible to realign the main displays and controls more closely at right angles to the line of sight, position them within easier reach and provide them with individual, glare-free sources of illumination. However, there would probably be minimal gain from these efforts, unless attention was also given to improvements in seat design and in environmental conditions of noise, vibration and temperature.

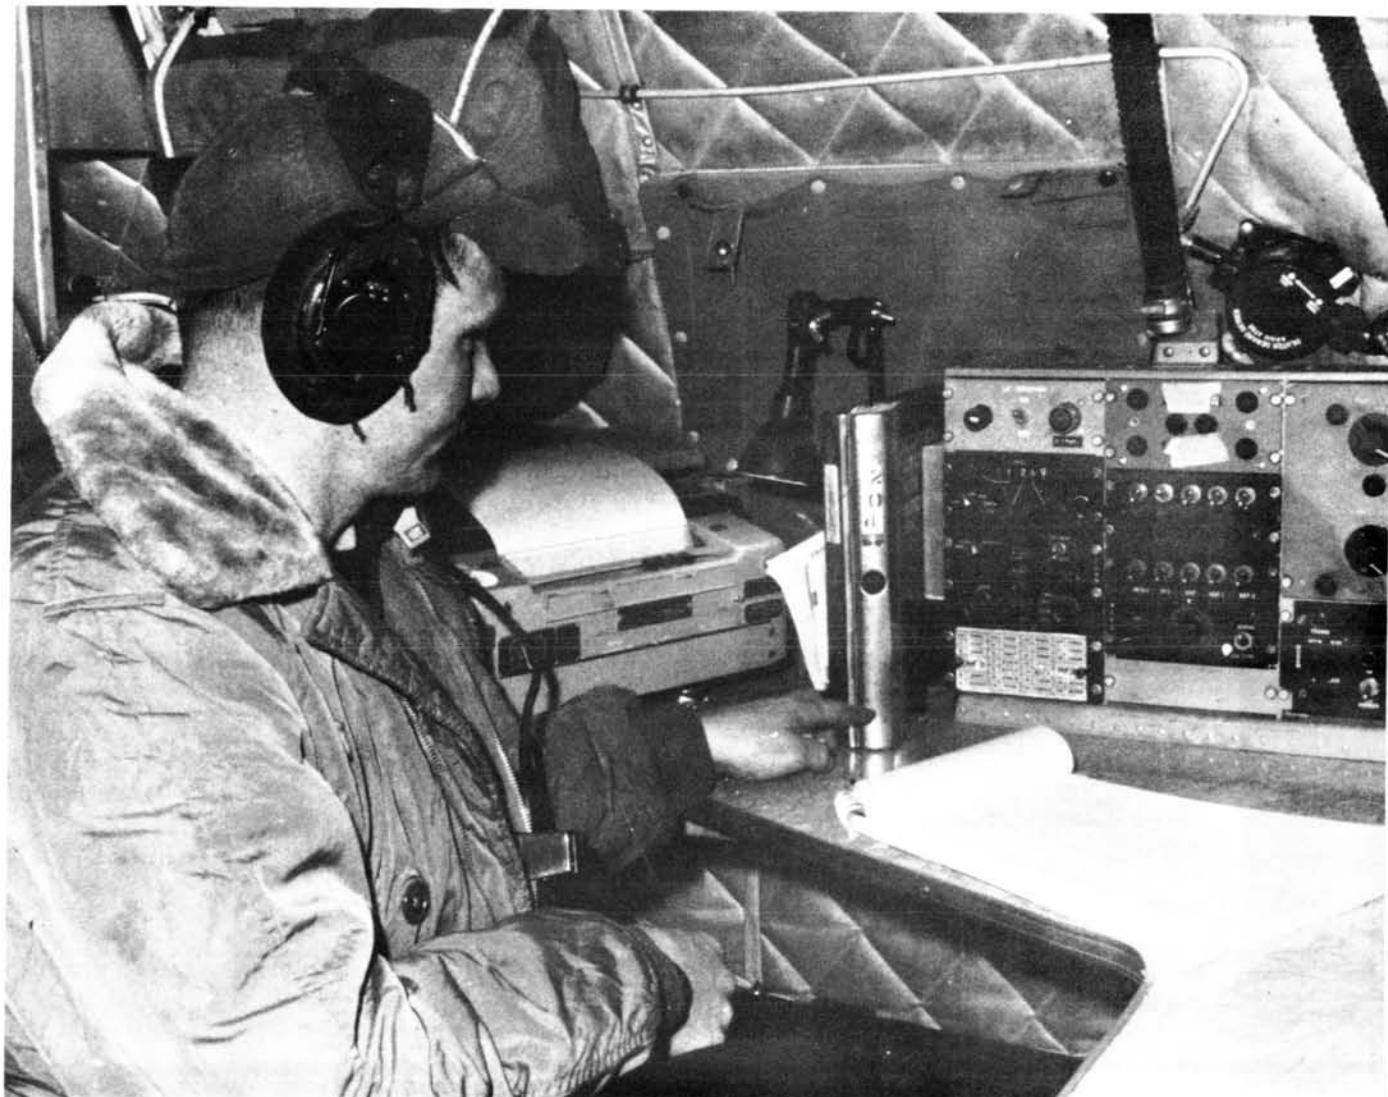
*Figure 5. Displays and controls extend beyond easy reach at the radio operator's station.*

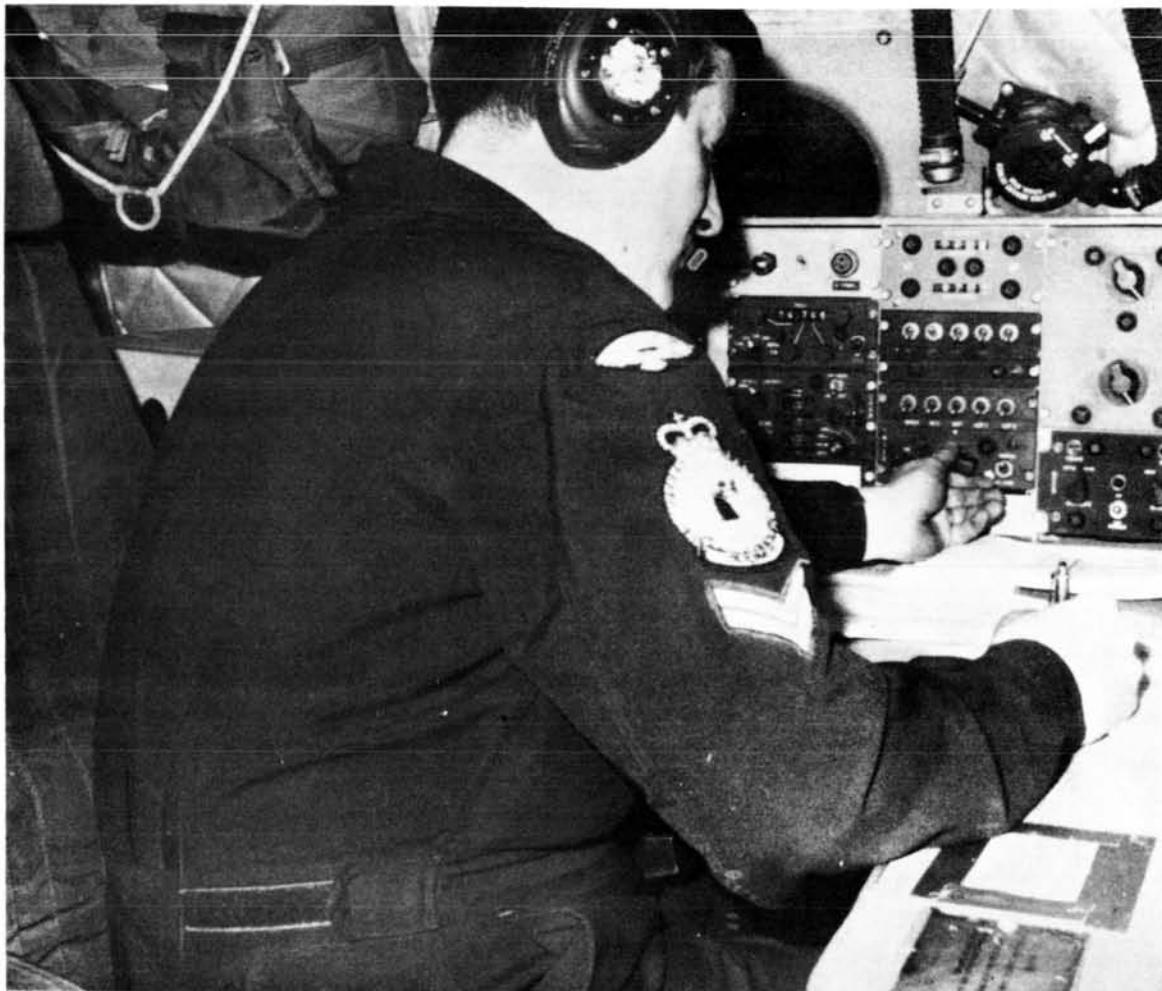
*Figure 6. The L-shaped layout of the radio operator's station imposes a tiring posture.*

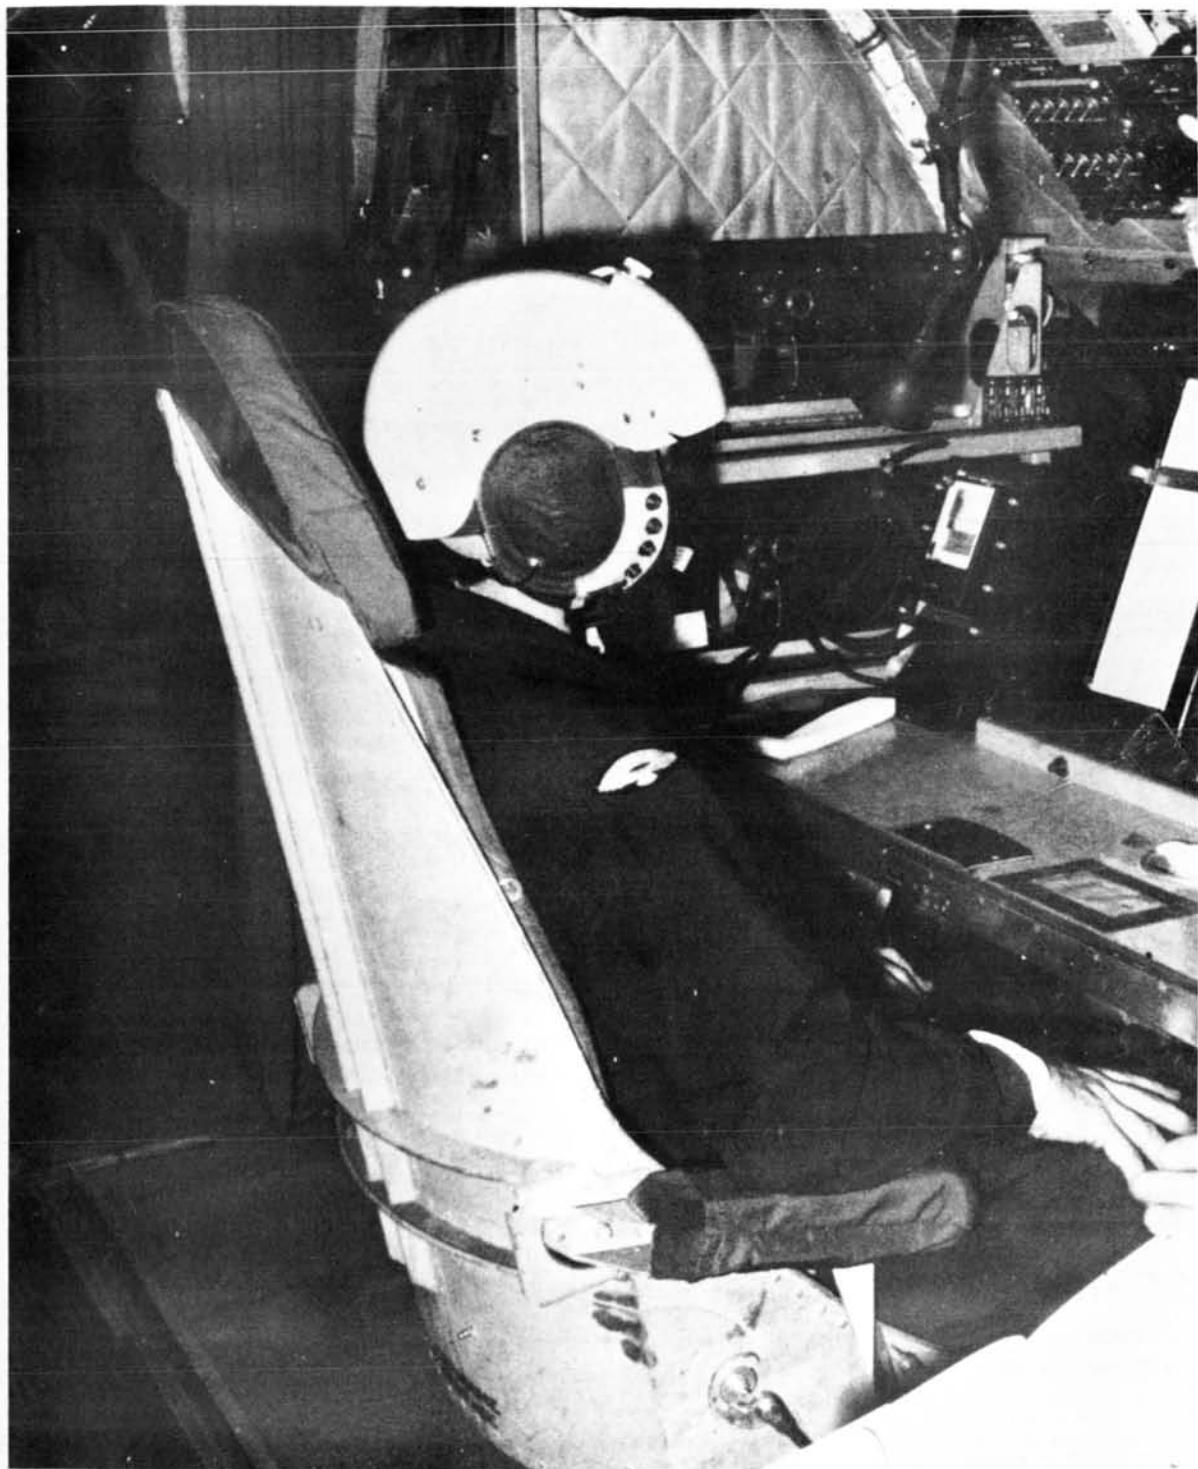
*Figure 10. The main display and overhead controls are too distant for a comfortably seated MAD/Julie operator.*

Short-term improvements could be gained by moving the tape-decks to a position nearer the Jezebel Operator, shifting the MAD/Julie station into the space so gained, repositioning the displays at a more convenient height and angle of view, and lowering the overhead control panel to within easy reach. The layout for both recorders should be standardized and colour-coded. Reel-in intercommunication cords should be employed.

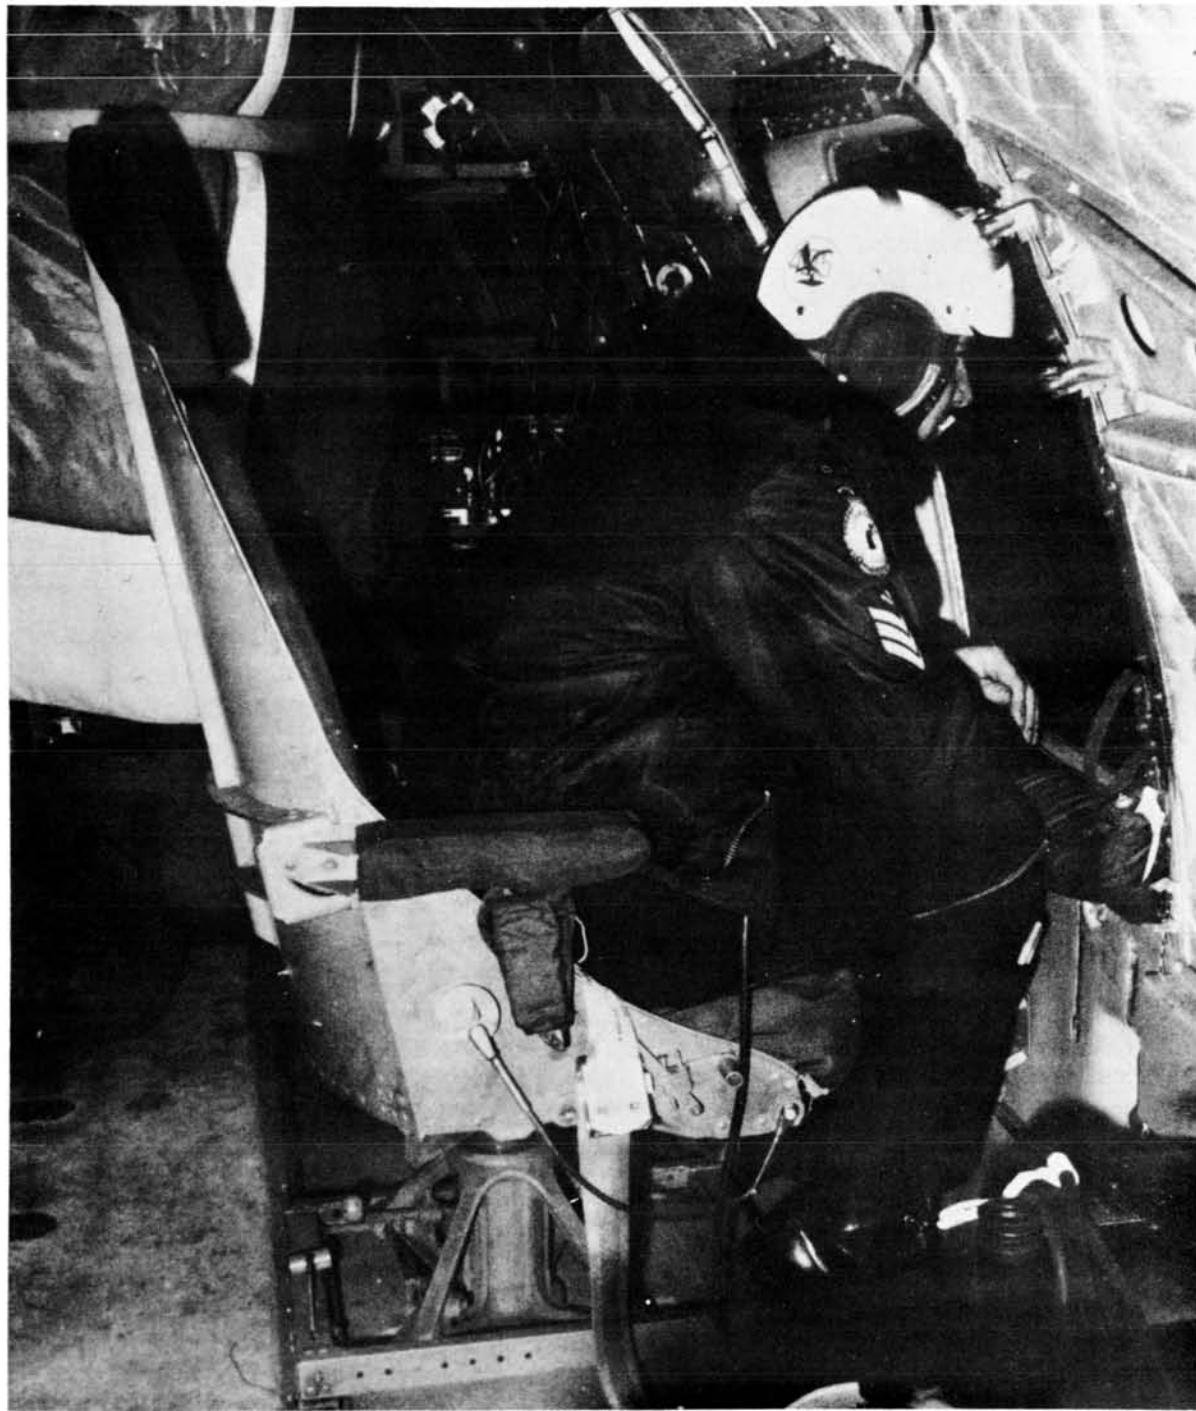
*Figure 11. There is inadequate foot-space for the beam observers.*

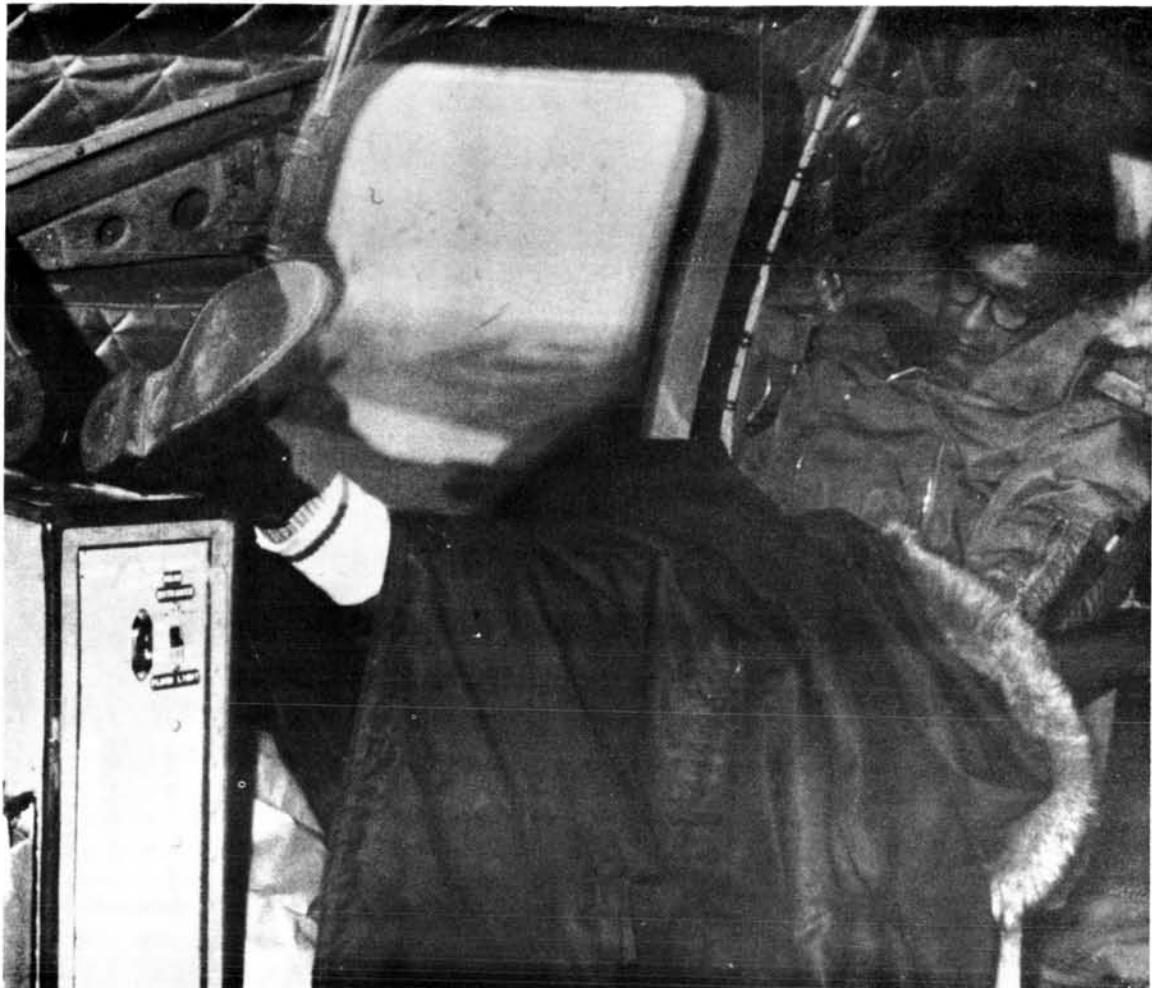
*Figure 18. Additional ground crew attempt to relax in the beam search station seats.*

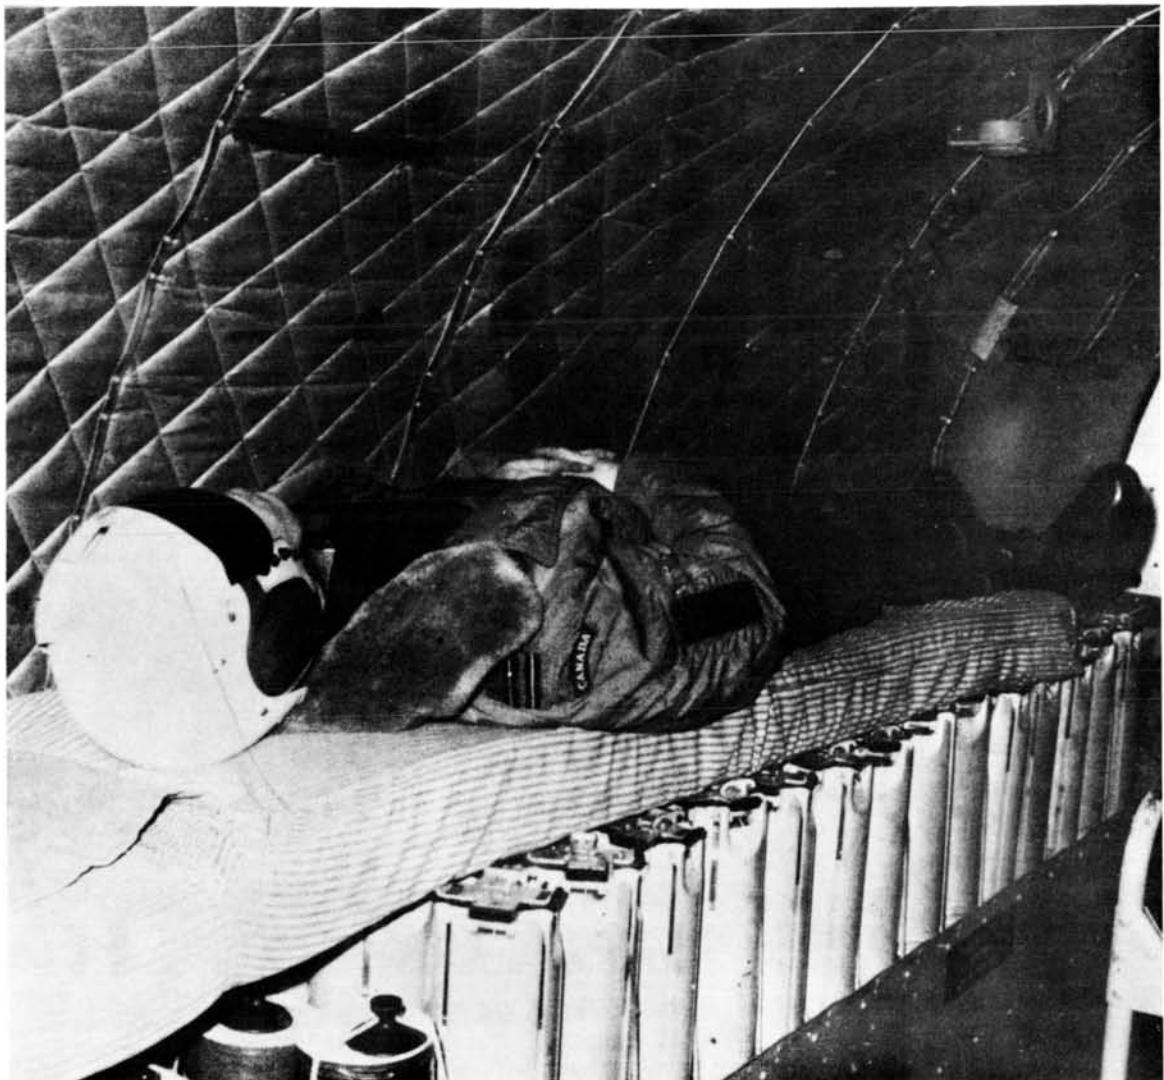
*Figure 17. Additional sleeping facilities are provided by throwing spare mattresses over the aft sonobuoy storage.*
